Commendable Home Inspection, LLC. ***Commendable Inspection Report***

1224 Morningwood Lane, Palm Harbor, FL 34666
Inspection prepared for: Kevin Customer
Real Estate Agent: Robin Realtor -

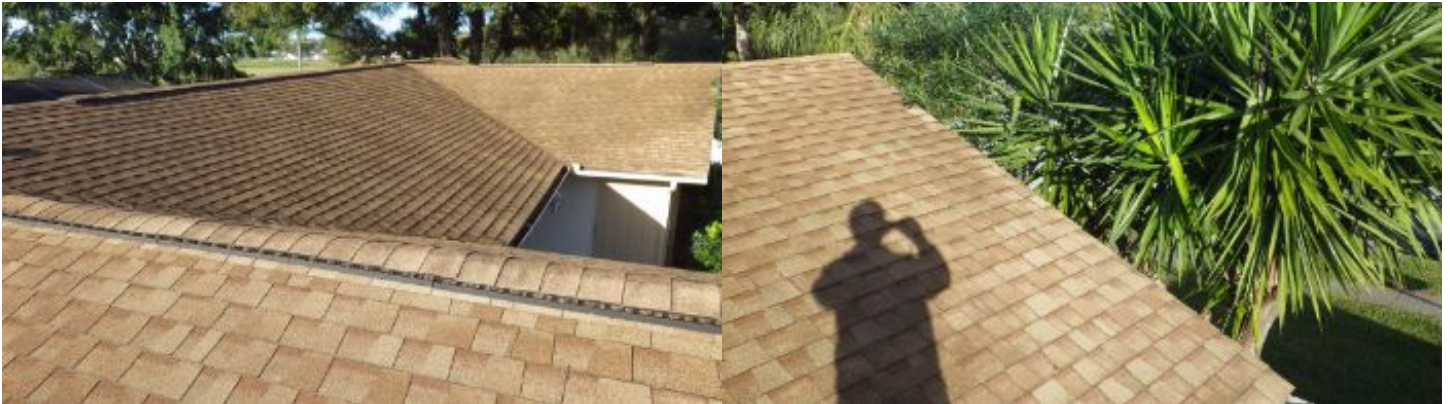
The county records indicate that the roof was replaced in 2006.

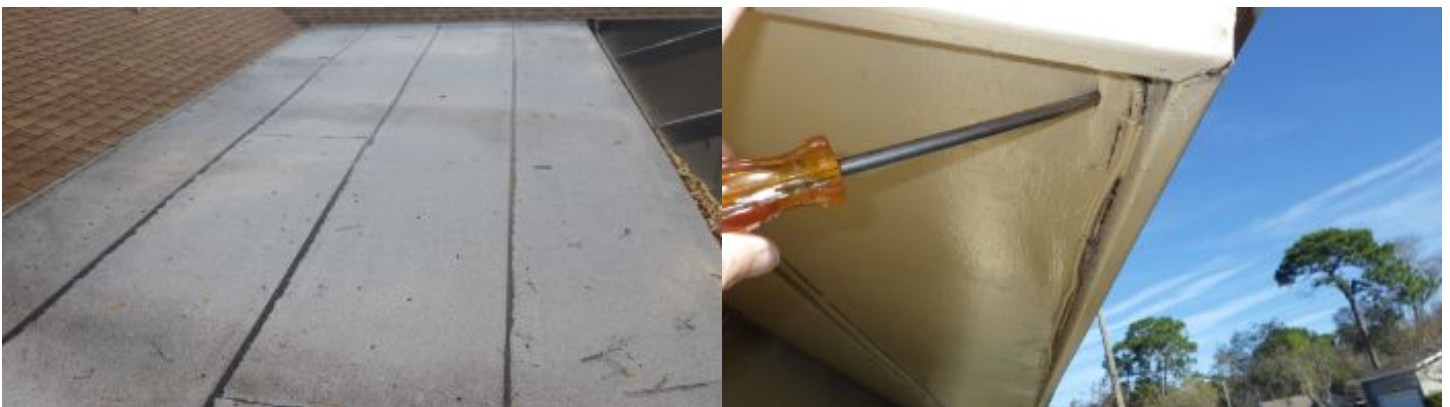
The flat roof over the rear patio appears to be the same age.

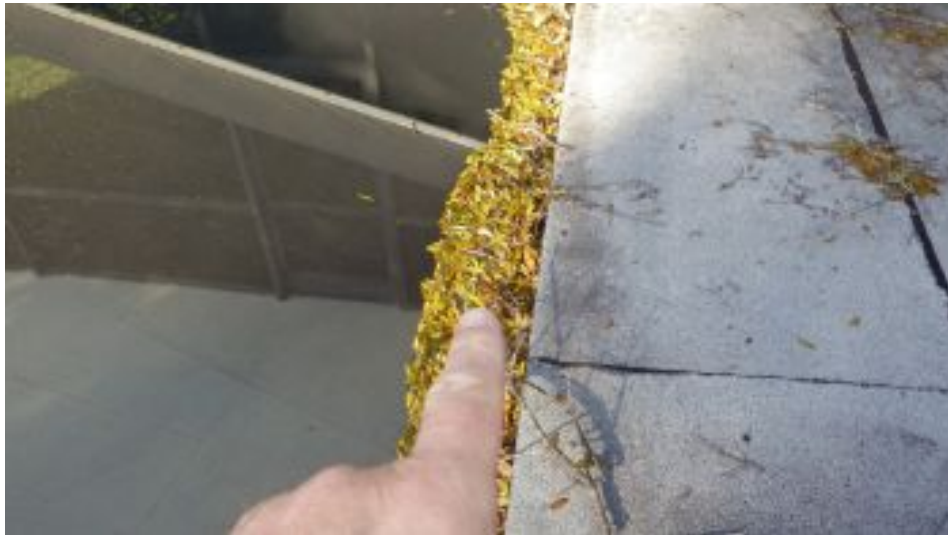
Gutters are filled with leaves in the back, this should be cleaned out to prevent overflow.

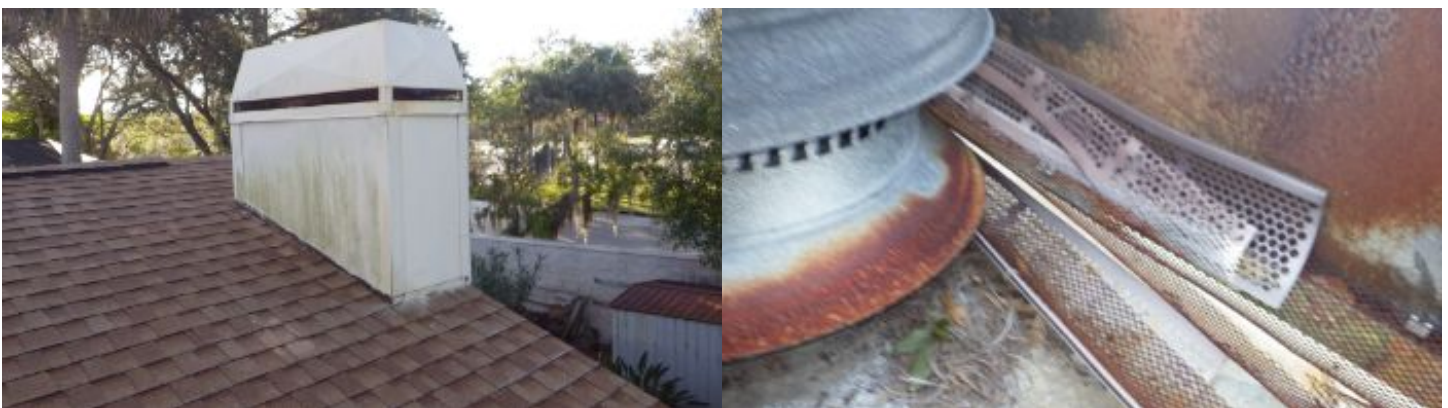
Crown and Flashing intact where visible. This is a wood frame chimney with a metal chimney pipe running up inside.

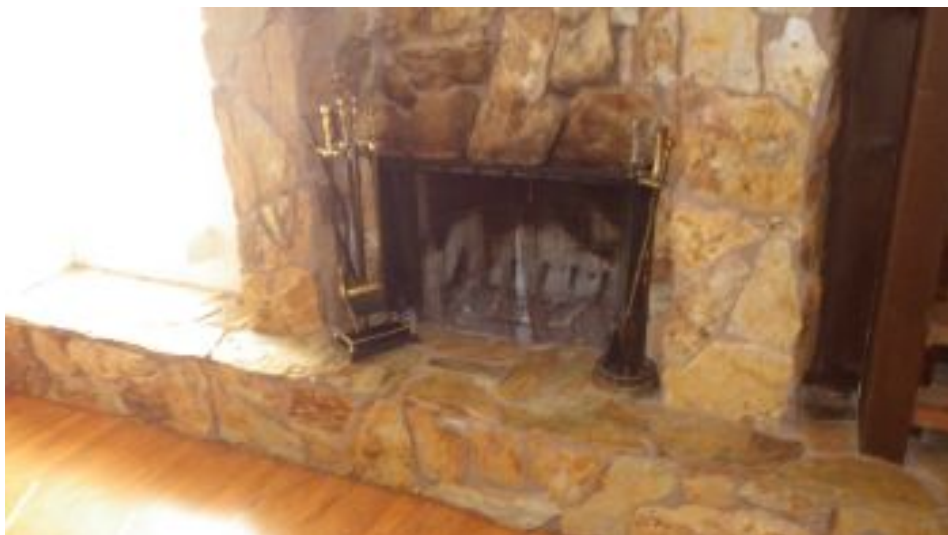
The chimney appears to be operational and in good condition, but view was limited.

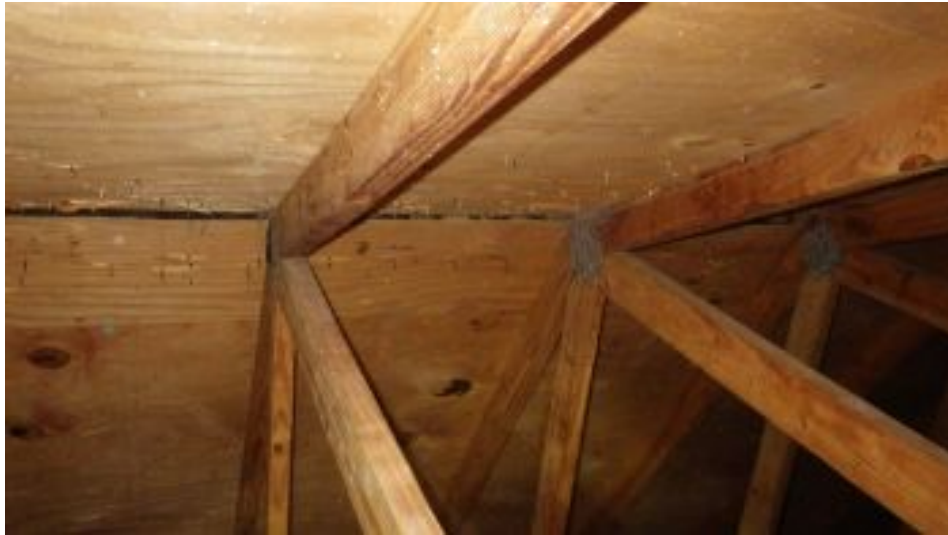
All visible areas clean and dry, except as noted

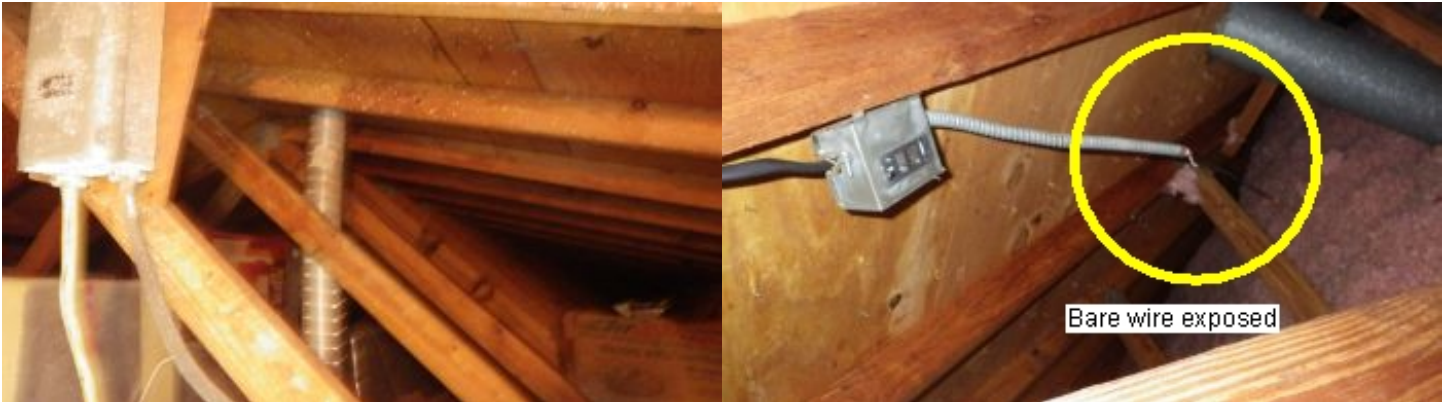
All bath fans, dryer, and range hood all vent through the roof.

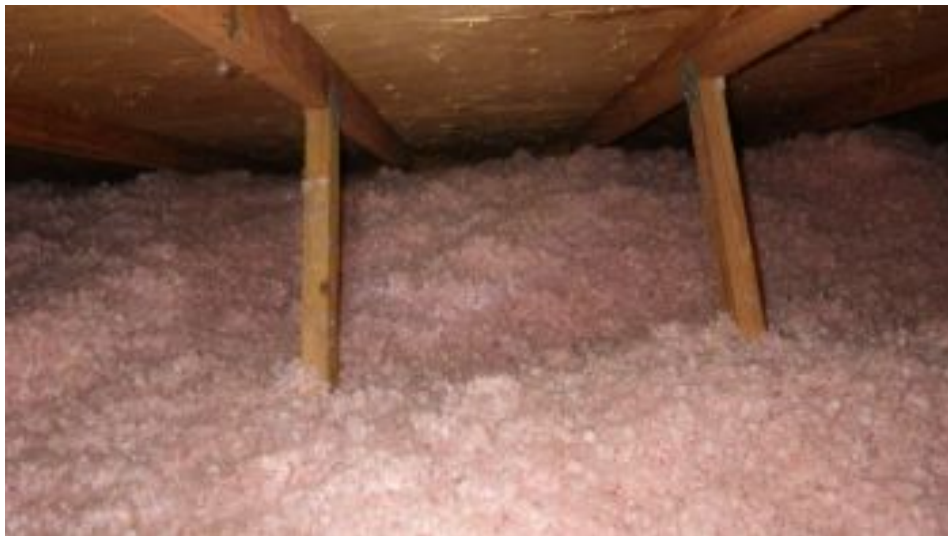
Blown in fiberglass on top of the old style rockwool fiberglass was observed in the attic.

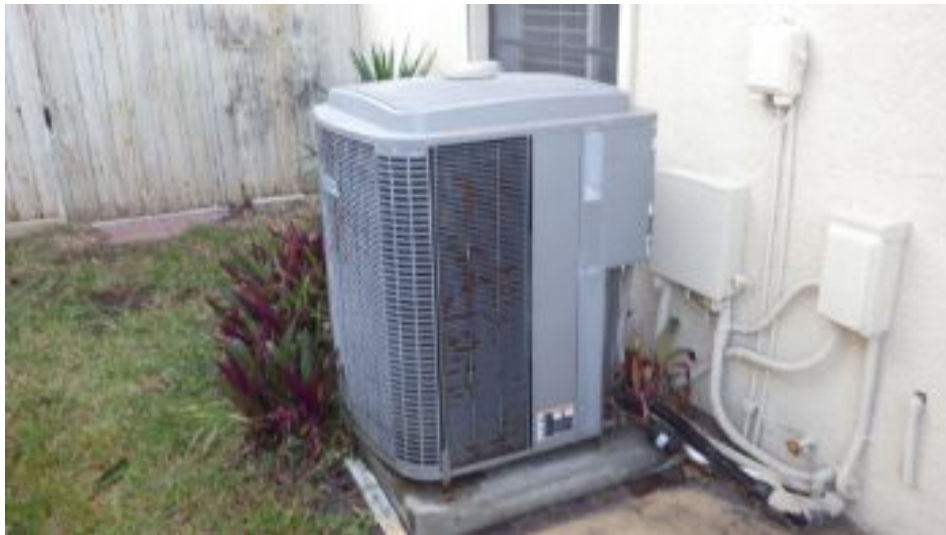
The unit was made in 2006. It is a 3.5 ton compressor made by International Comfort Products® corp.

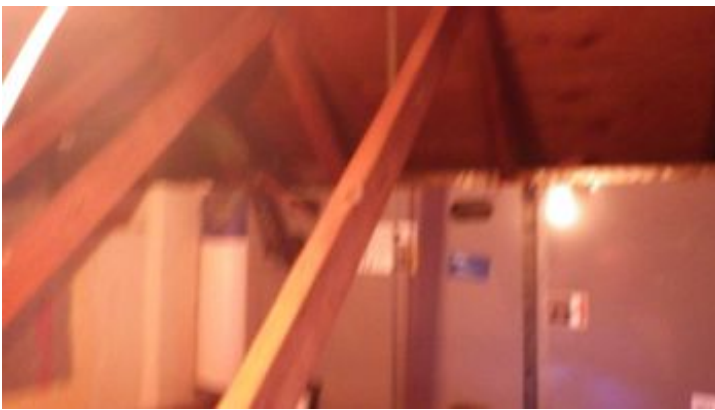
The air handler was located in the attic .

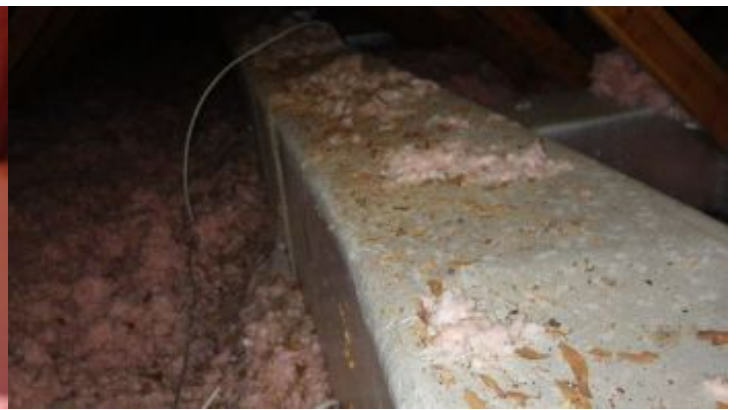
Duct work was primarily located in the attic, and appeared to be in satisfactory condition overall, except as noted.

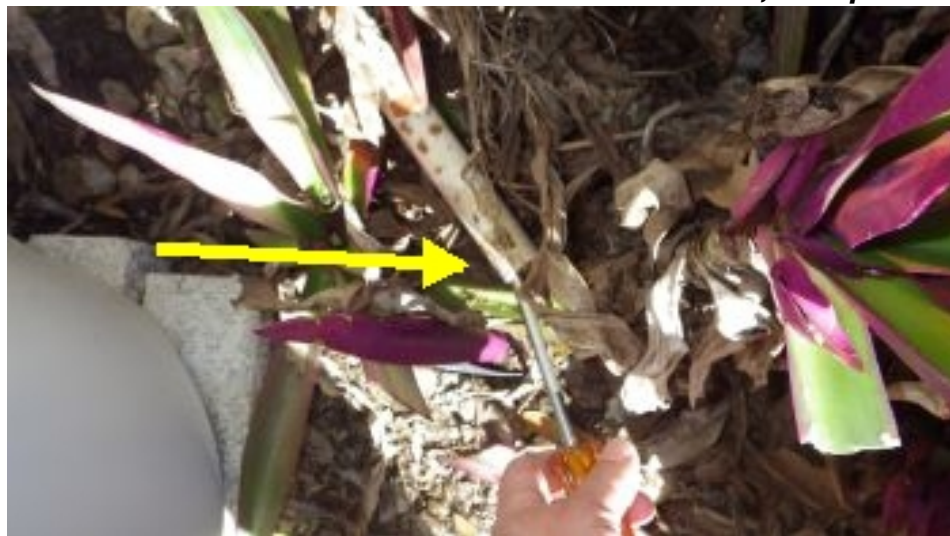
Condensate drain line is buried in plants behind the compressor.

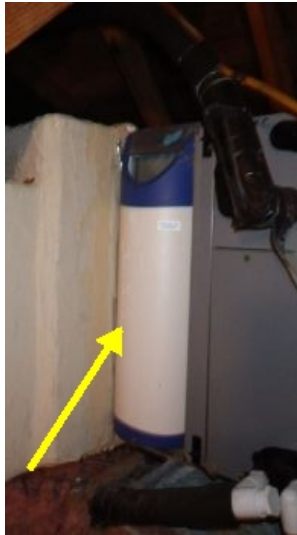
System filter sizes: (large pleated type in the main return air line in the attic)

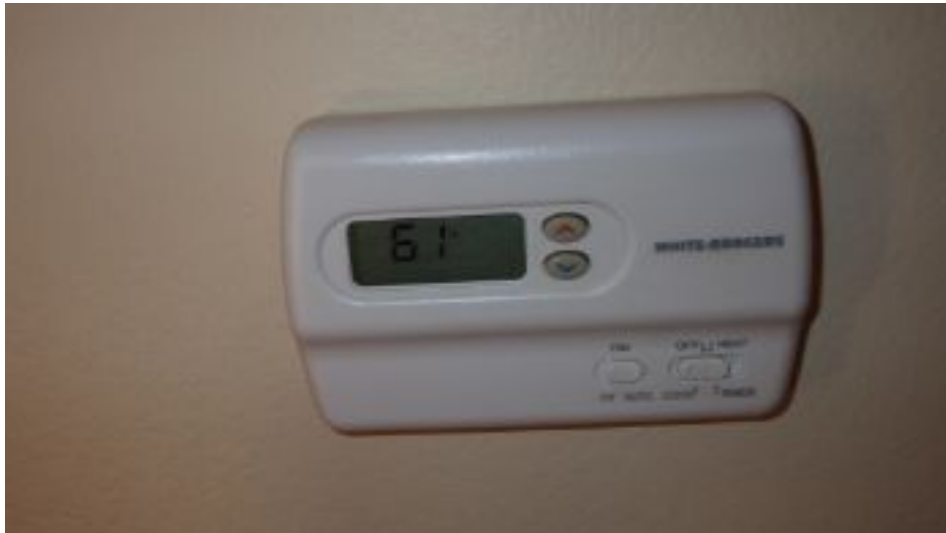
Digital - NON programmable type.

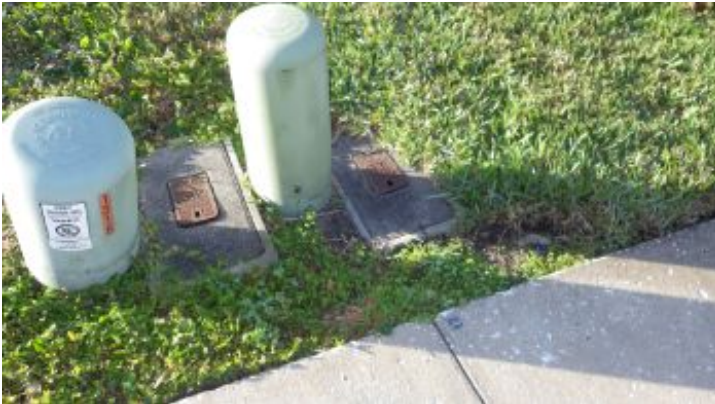
The main shutoff and meter is located in just off the sidewalk on the east side of the front lawn.

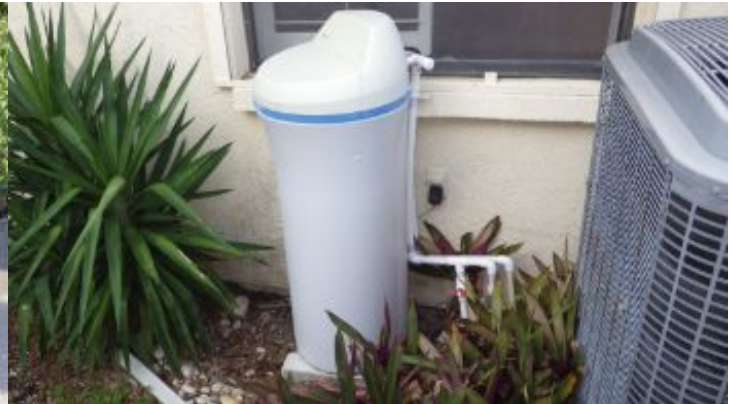
A water conditioner system is present in the house (on the east side outdoors) and Does appear to be functional.

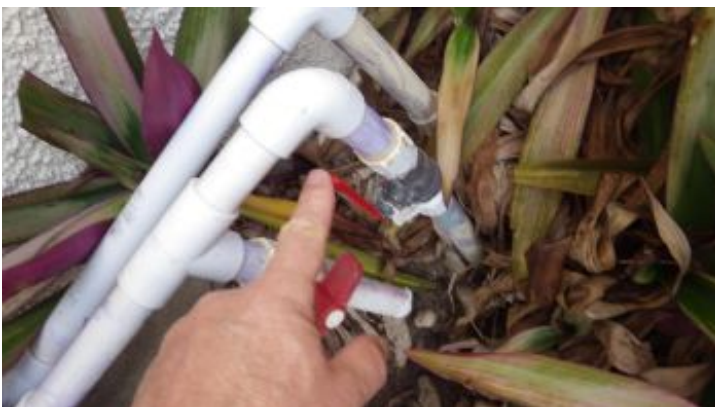
The main water shutoff valve is located on the east side of the house at the water conditioner.

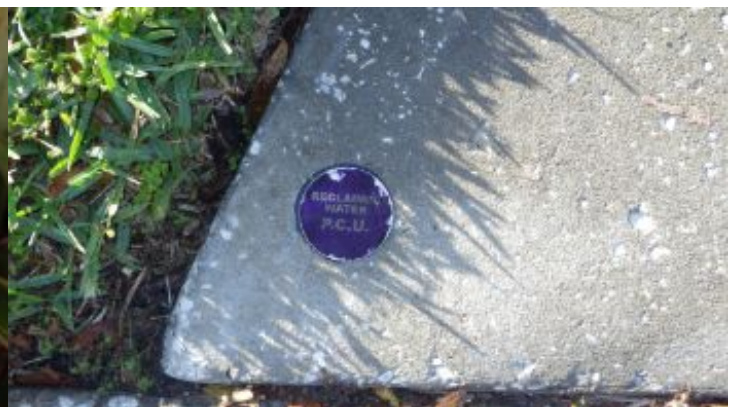
Reclaim water for irrigation is connected

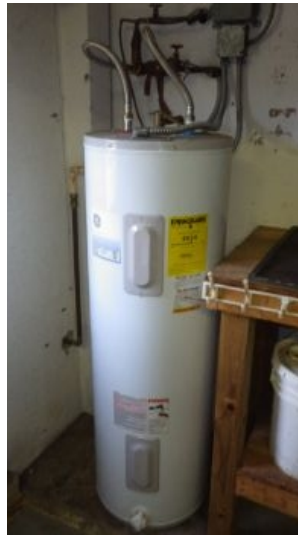
The hot water tank in the garage is a 50 gallon upright unit made by Rheem® that registered water temperatures at 116F.

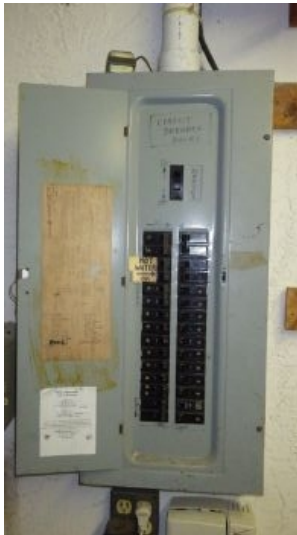
The main breaker panel is located in the garage.

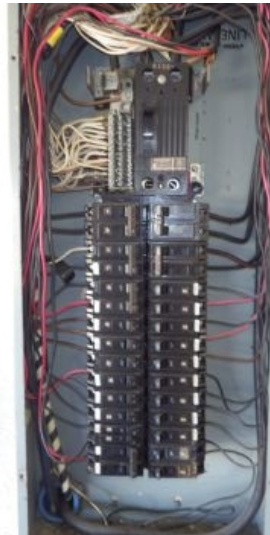
Removal of the cover panel on the circuit breaker panel revealed no significant issues, except as noted.

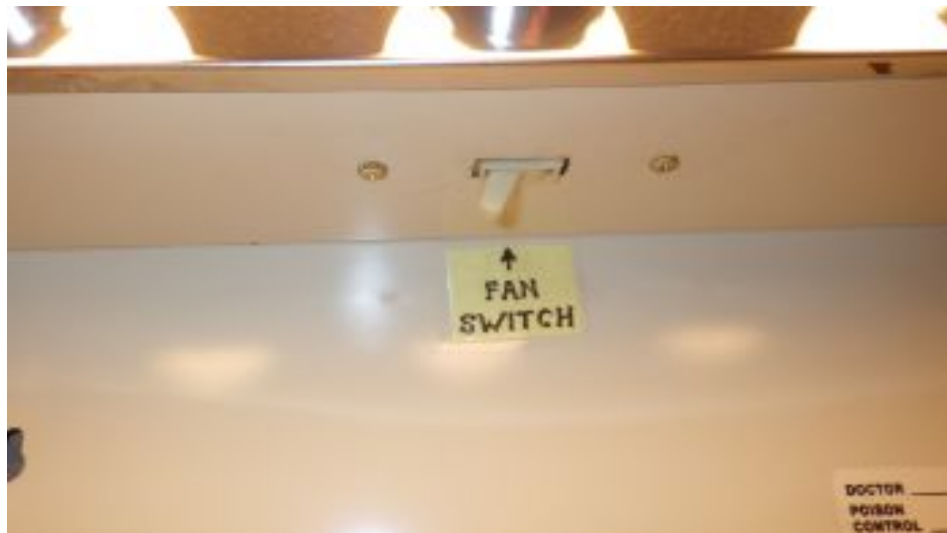
Non Standard workmanship for a light fixture and switch for the exhaust fan in the half bath.

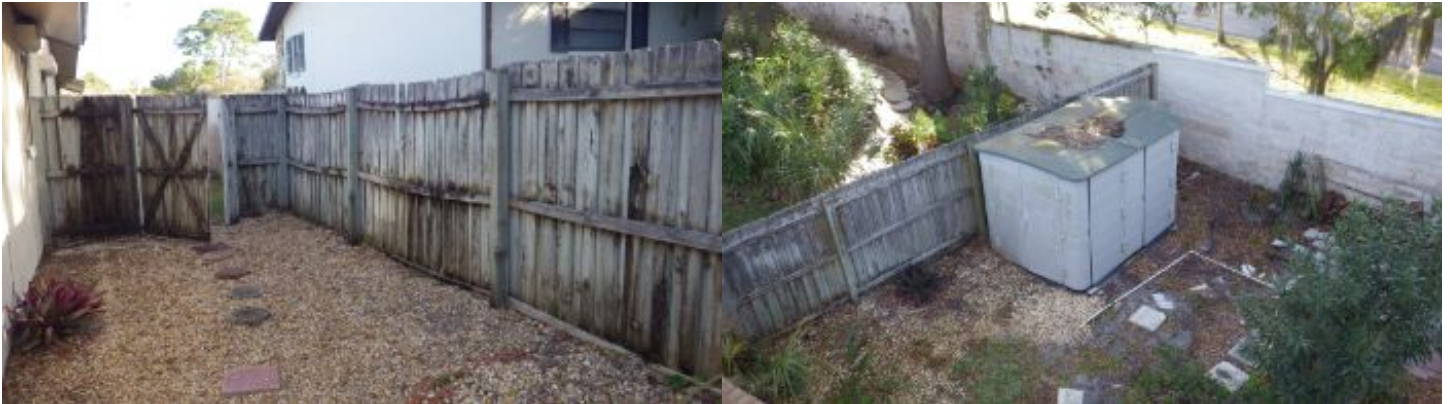
Wooden privacy fence is in poor condition with some missing slats, staining and panels not entirely secured to posts.

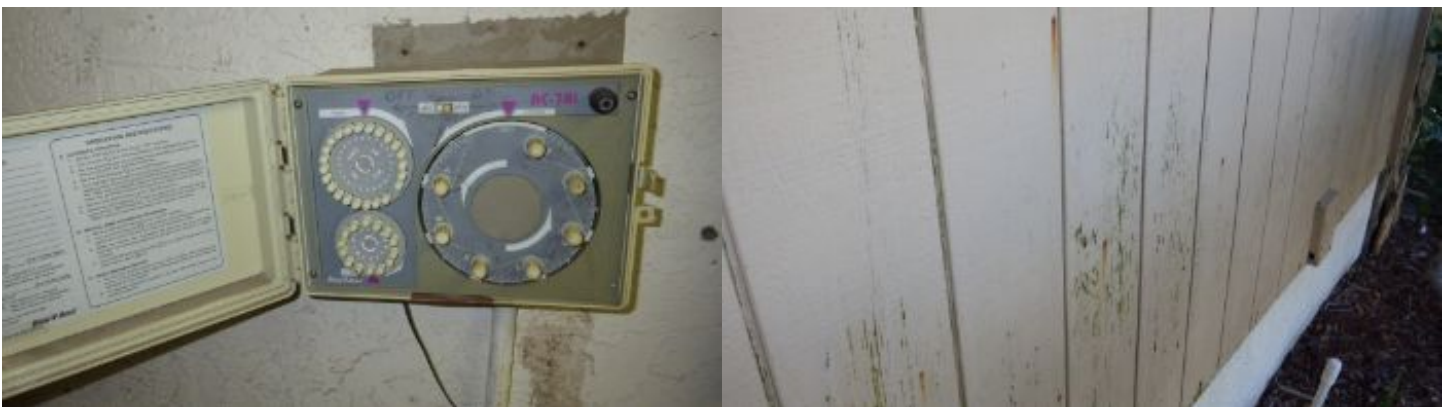
A 7 Zone irrigation system was present and operated normally.

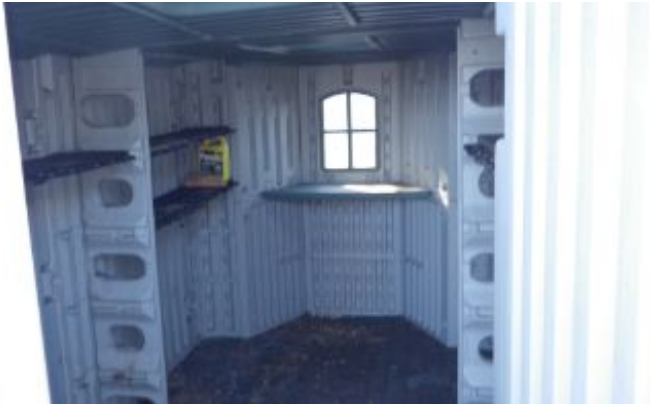
PVC Shed observed in rear of property

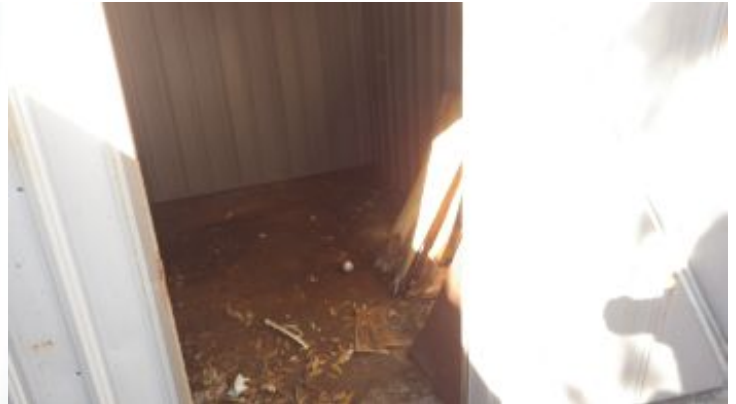
The metal shed doors were rusty, and the wood deck appears to be decayed and stained.

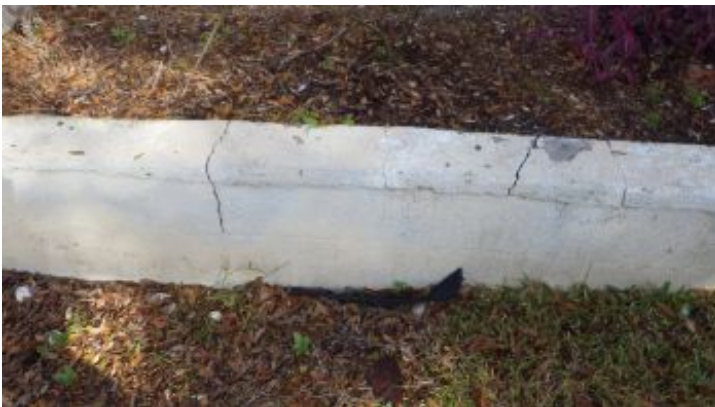
masonry retaining wall near fireplace is cracking in several spots.

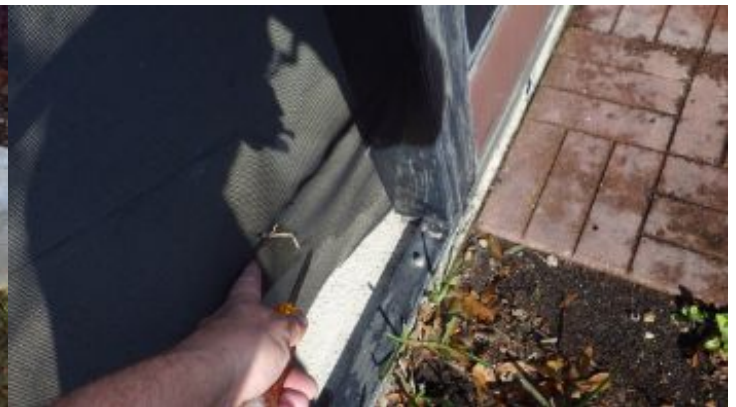
Pool screen cage has some visible damaged screens, and doors. The east side panels are torn on the enclosure.

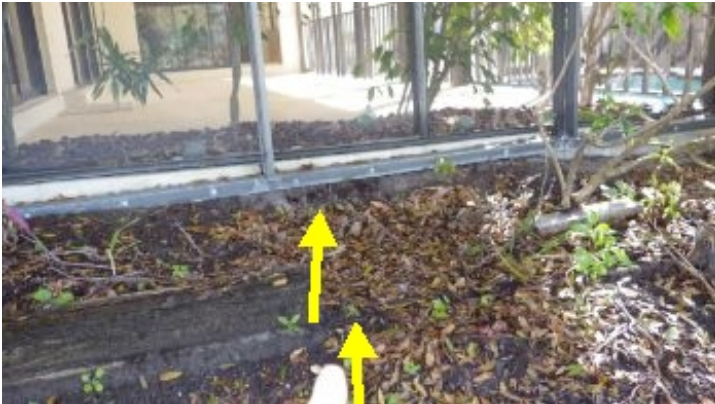
Wooden retaining wall on west side is severely decayed and a large section has failed. The garden above the retaining wall has washed away with the deck of the patio losing support.

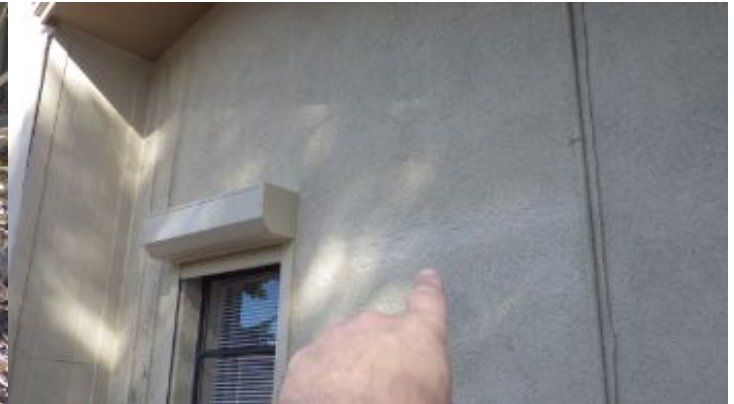
Obvious crack covered by stucco spray texture.

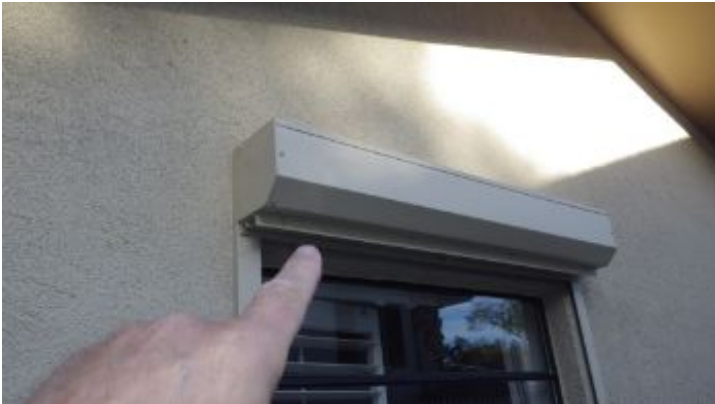
All roll down storm panels appeared operational except the one on the west side of the patio.

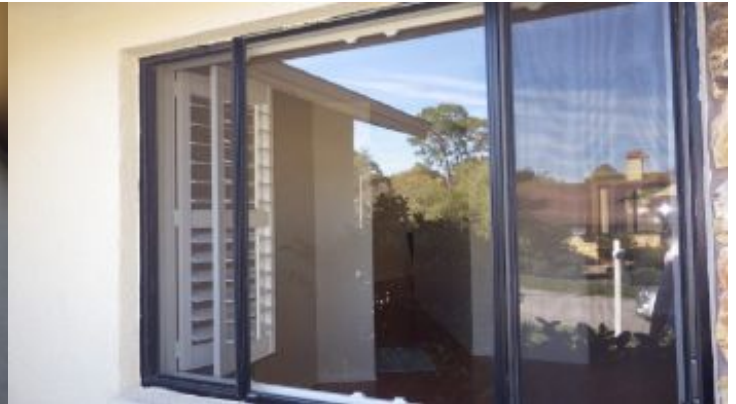
All tested windows were operational, except as noted Most are single hung single glazed, non impact windows with a few sliders.

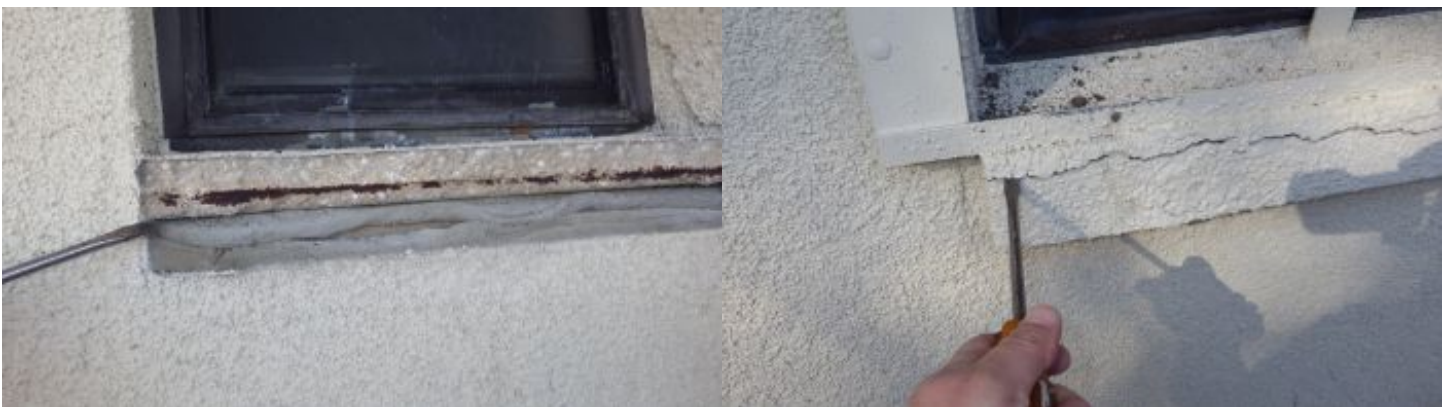
Window sills are made of concrete and several were noted as damaged or cracking. The one on the master bath window (West side) was broken right off

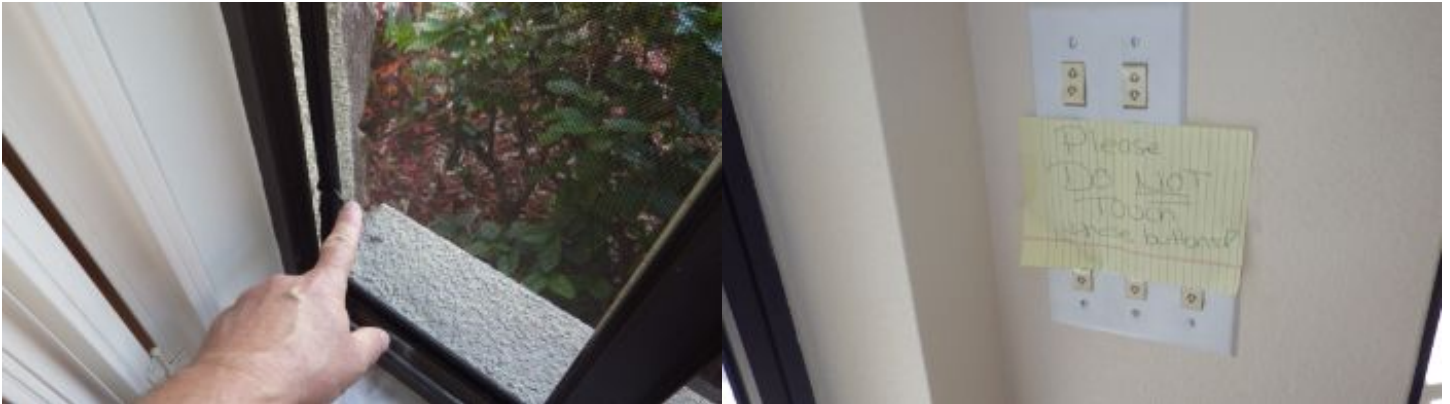
Screens are damaged or frayed in a few windows.

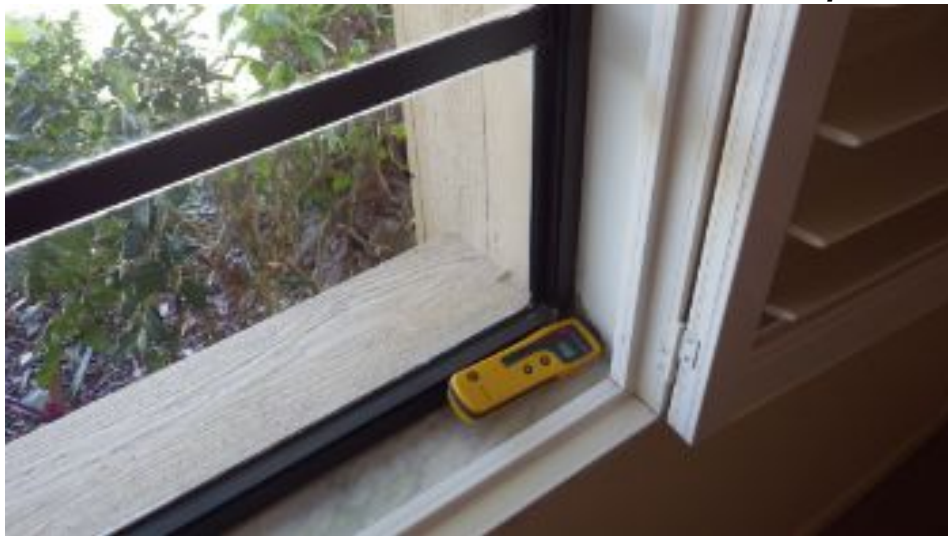
High moisture readings noted at the windows in several rooms

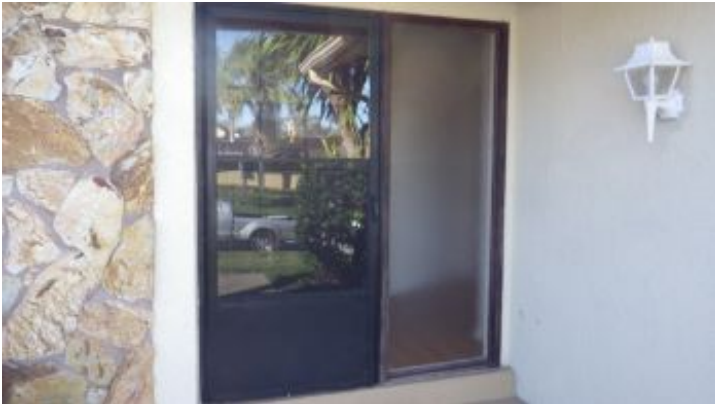
No major issues noted with any doors. All appeared operational and intact, except as noted.

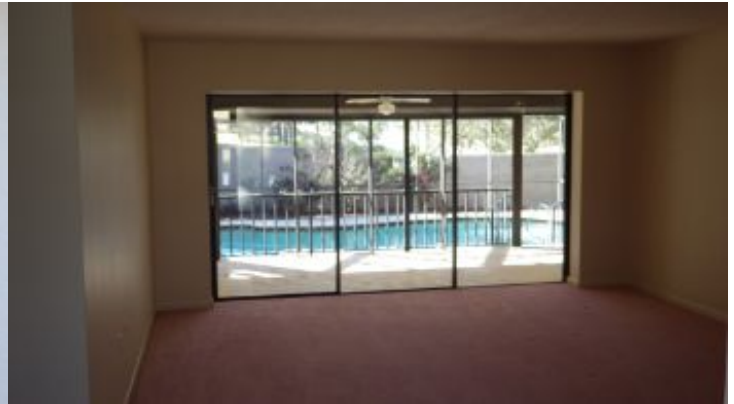
Patio doors are operational. Continue normal maintenance such as cleaning and lubricating

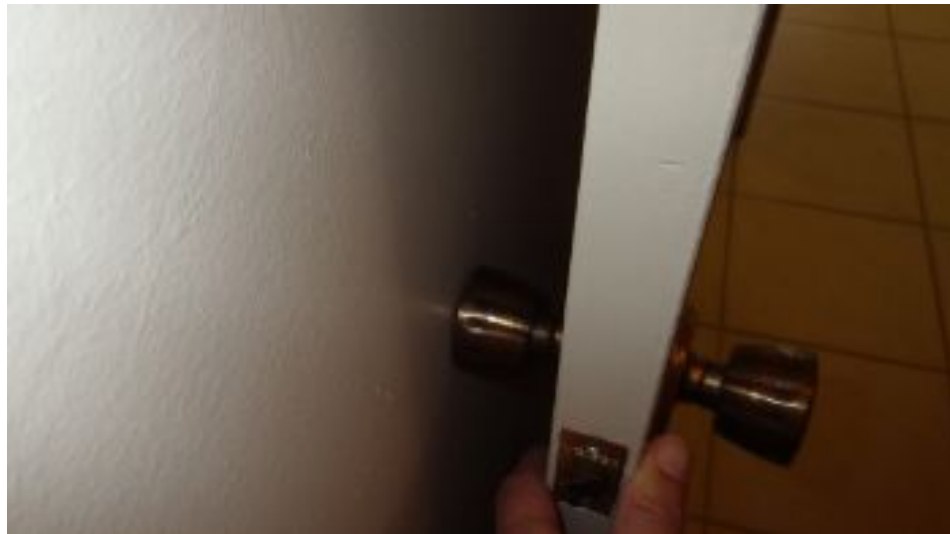
few door stops were present. Damage may result from knobs hitting the drywall.

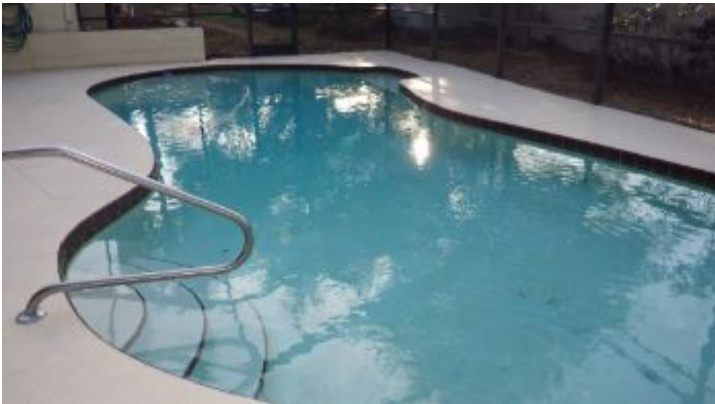
Pool plaster finish has served its useful life and is damaged. The concrete is showing through the plaster in some spots.

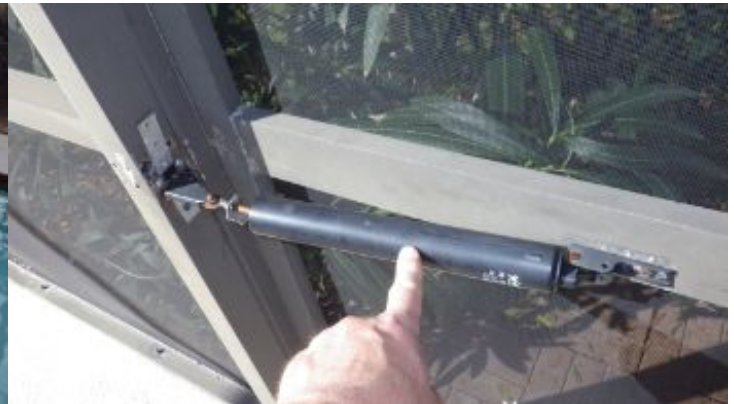
Both screen doors have issues with latches and piston closers.

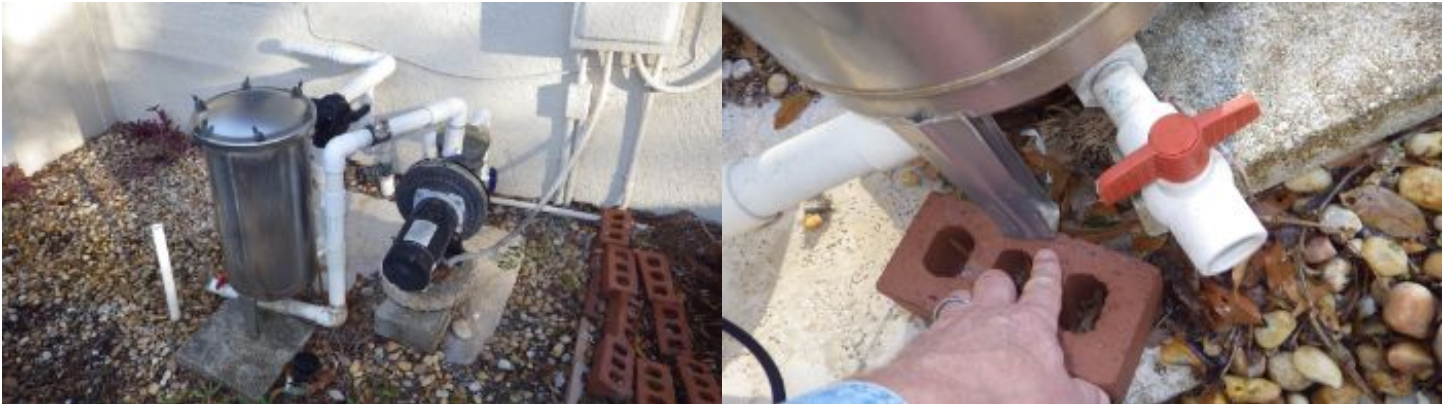
A single pump, no chlorinator, no flow control valves, and a stainless steel cartridge filter housing all appear to be fully operational.

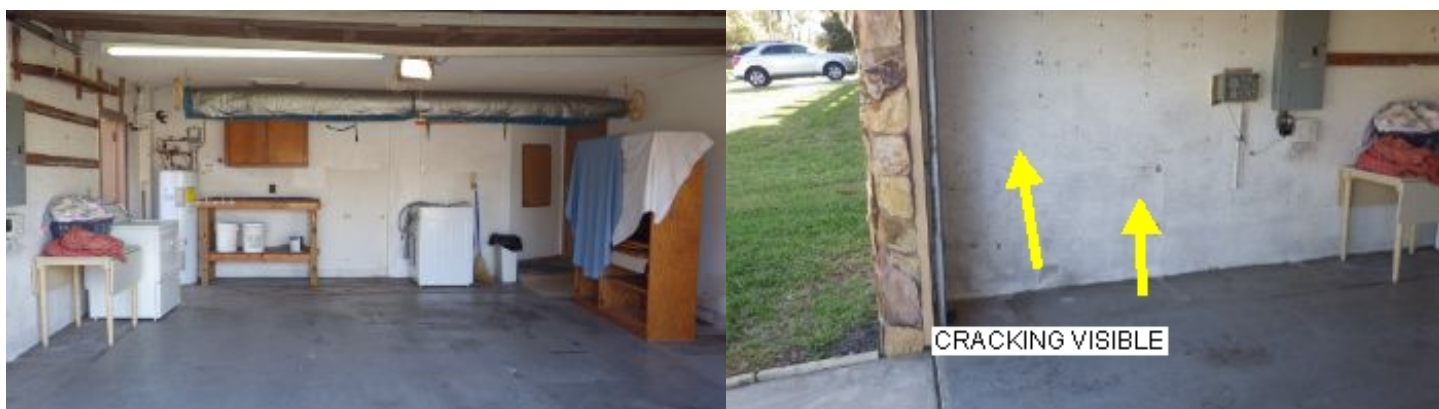
garage was clean and dry.

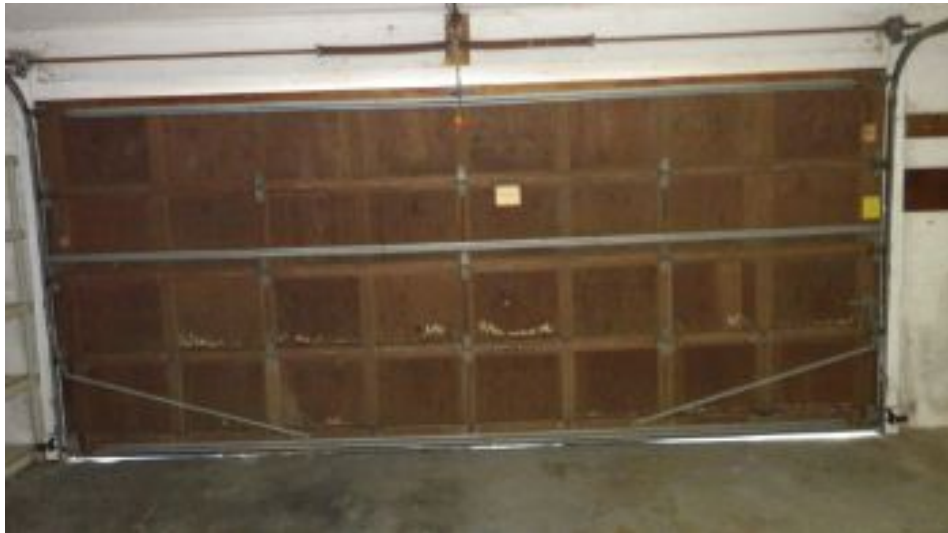
One original 16' wooden door with torsion lift spring. Minor wood stains from various leaks but door appears intact.

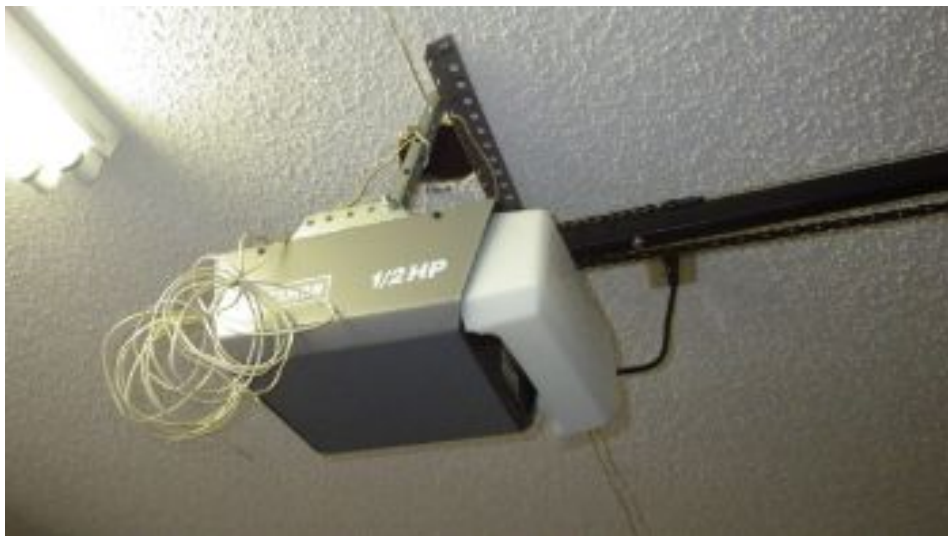
The garage door opener is functional, all safety tests were conducted and passed by door opener.

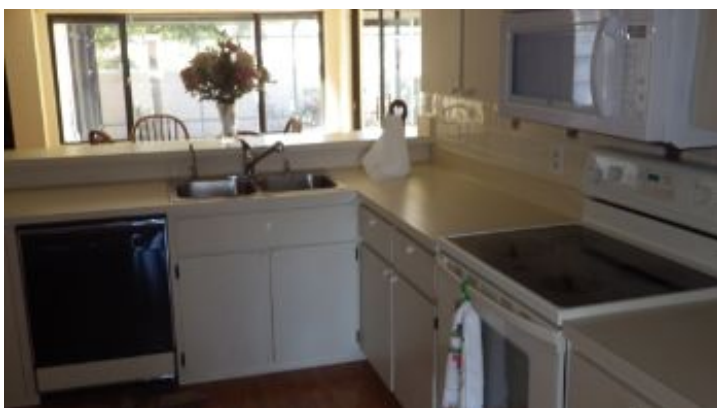
Kitchen cabinets, appliances, fixtures, lighting and counters appear sound and clean except as noted.

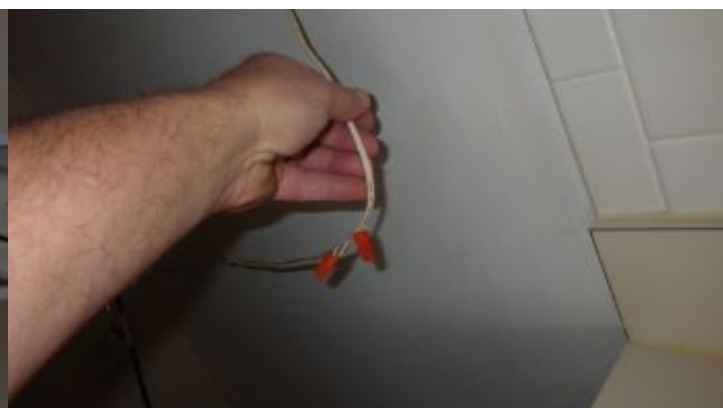
Under counter fluorescent lighting is using a spliced, wire nutted, lamp cord for power source. See behind the refrigerator.

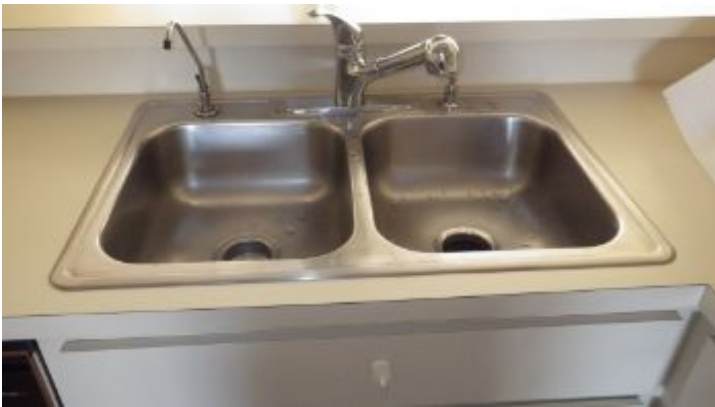
Kitchen has a Stainless steel - surface mounted sink

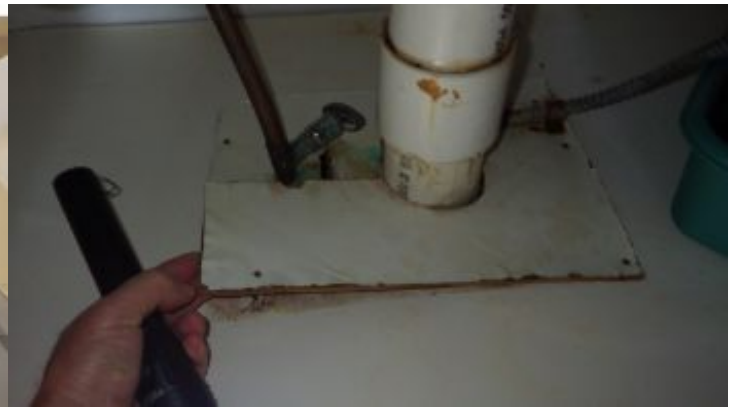
The sink cabinet base wood was slightly damaged by presumed past leaking.

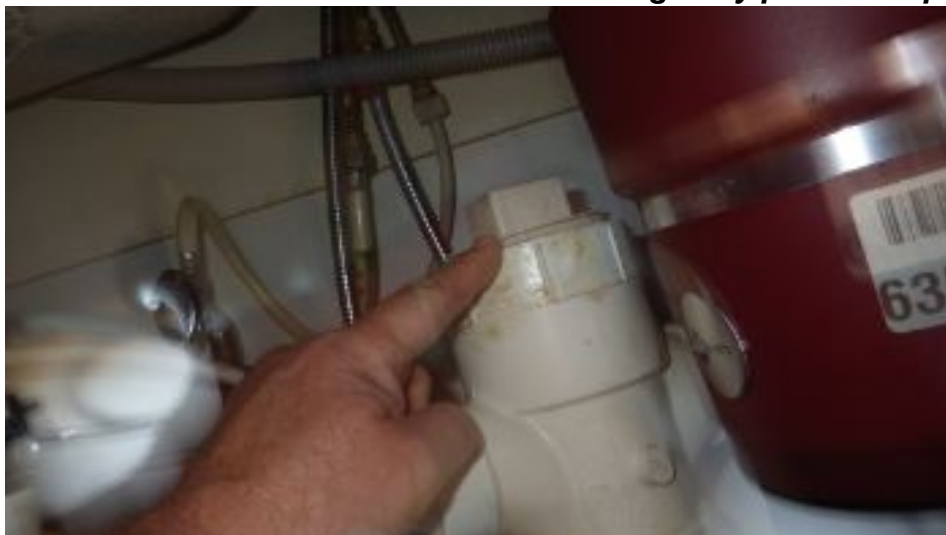
An air admittance valve should be added to the drain pipe to allow easy drainage of the sinks, especially the disposal side.

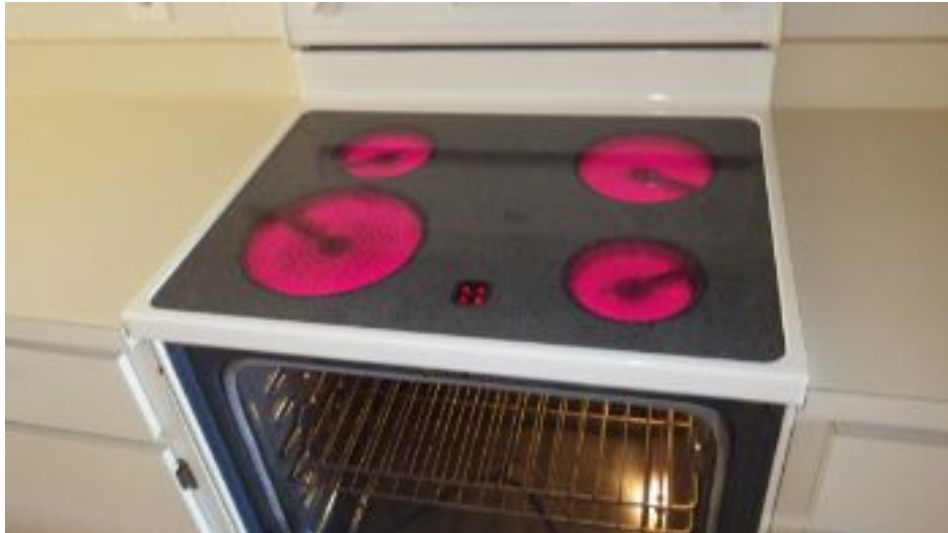
All heating elements operated when tested.

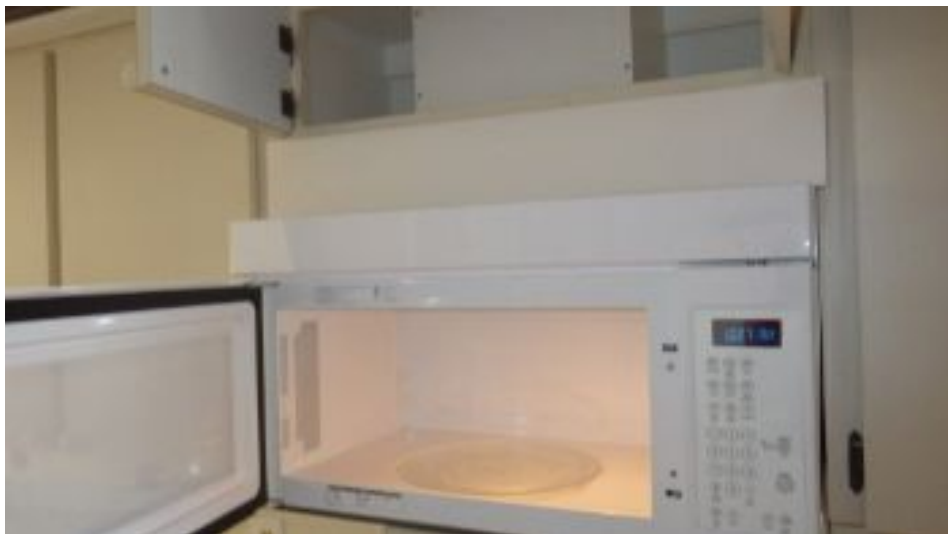
Built-in microwave oven was tested and appeared operational at time of inspection.

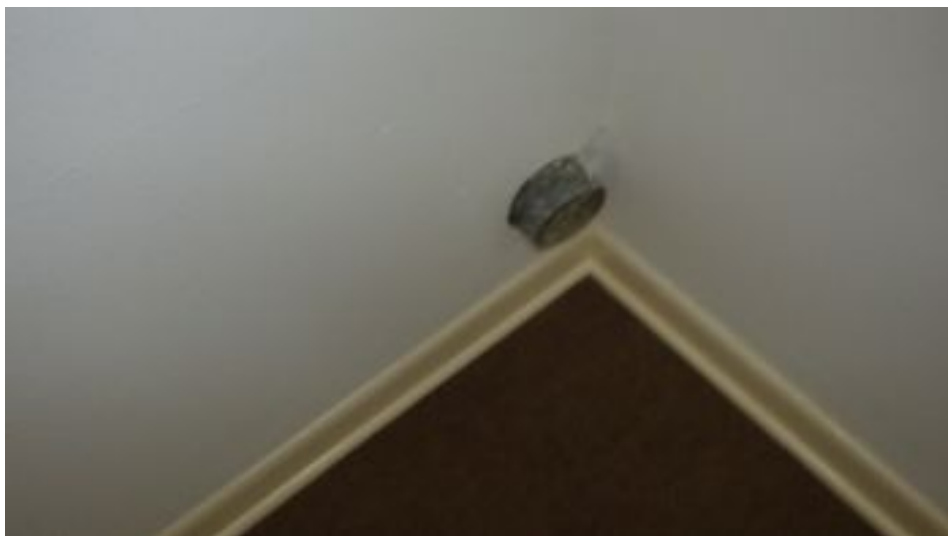
The dryer vent should be cleaned prior to occupancy.

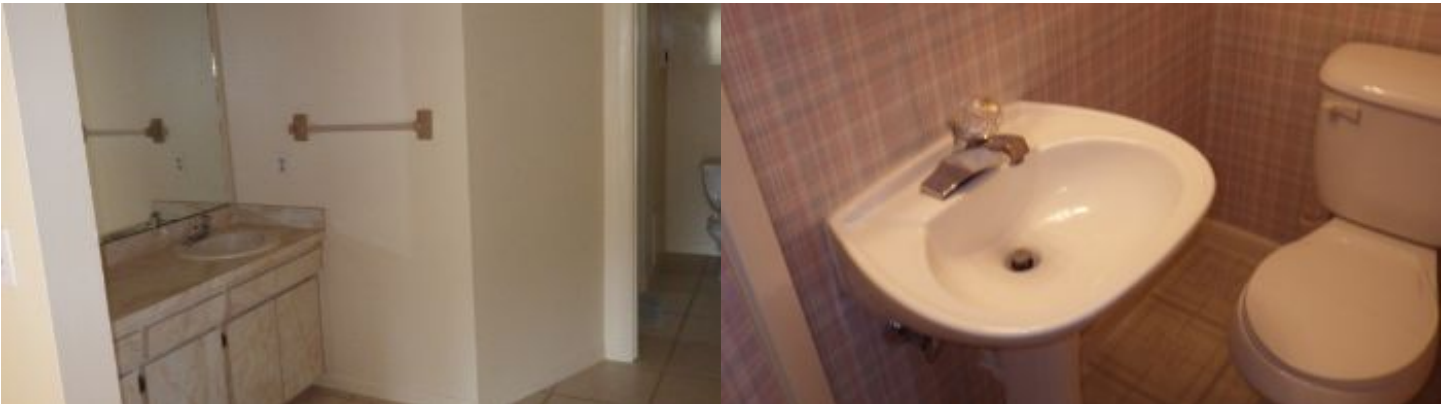
- The inside door knob in the half bath is a interior closet release handle
- **Non standard construction of the half bath. The room appears to be a modified closet. the normal clearance specified in Uniform Plumbing codes (UPC) around fixtures is marginal or ignored in this bath. 21" clearance in front of the toilet or sink is ignored as the fixtures interfering with each other, and the entry door. Clearance is required for repairs and emergency rescue. 15" clearance to the sides of the toilet just make it, but the entry door to the bath is blocked by the sink down to 15". This was not a permitted project and likely not finished by a licensed plumber.**
