Commendable Home Inspection, LLC. ***Commendable Inspection Report***

1224 Morningwood Lane, Palm Harbor, FL 34666
Inspection prepared for: Kevin Customer
Real Estate Agent: Robin Realtor -

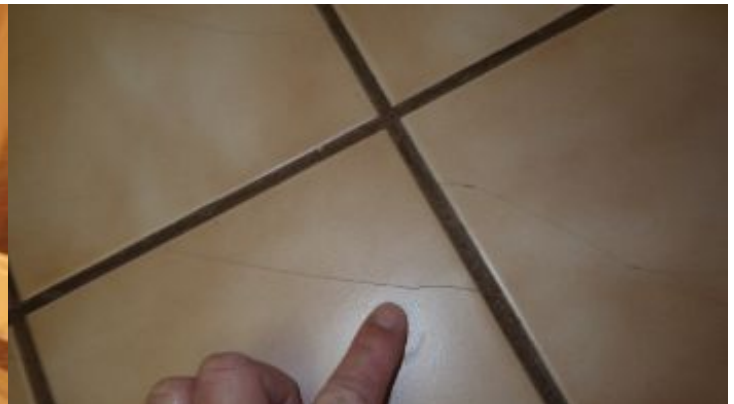
**The tile floor in the hall bath is not secure to
the substrate. The tiles are cracking, because
they do not stick to the subfloor.**

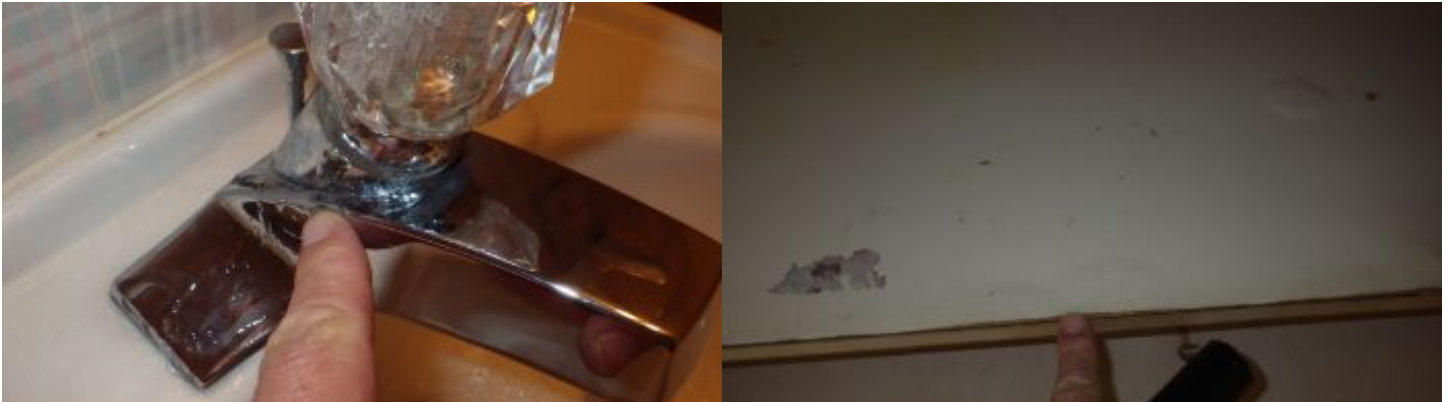
Faucet leaks at handle in half bath when in use on cold.

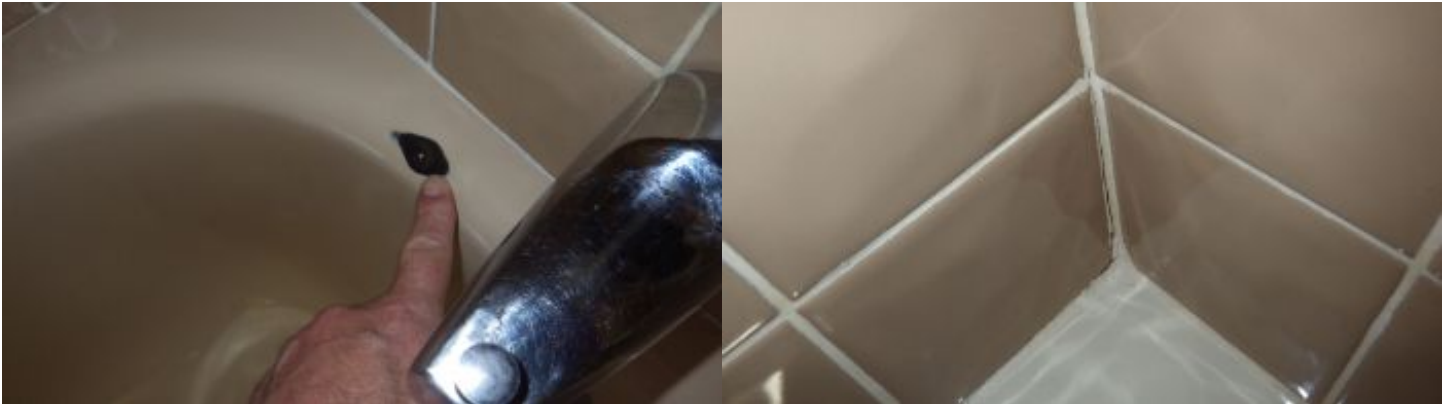
There was a large chip observed in the tub in the hall bath

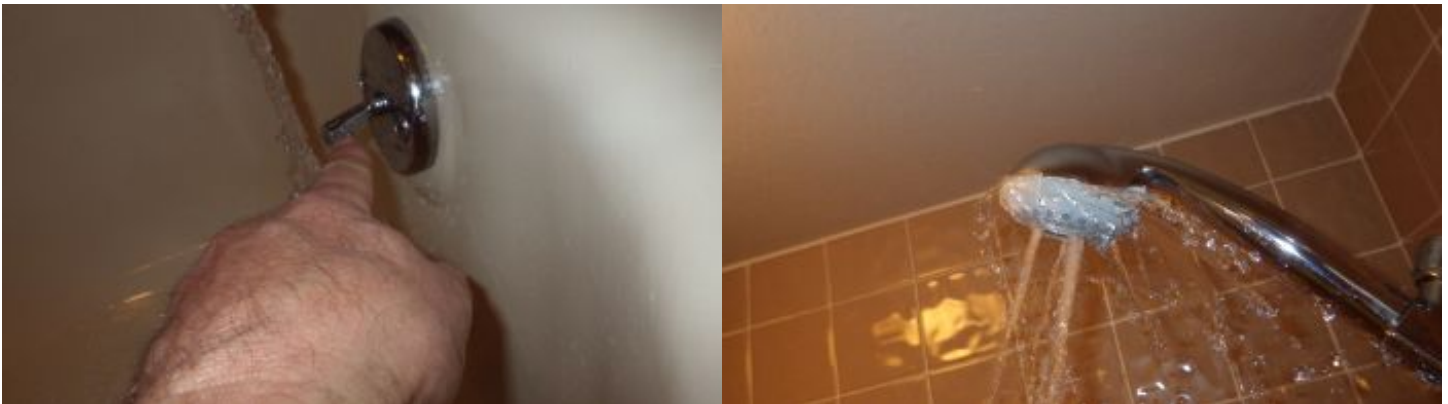
The drain stopper lever in the Master bath has rusted and does not operate.

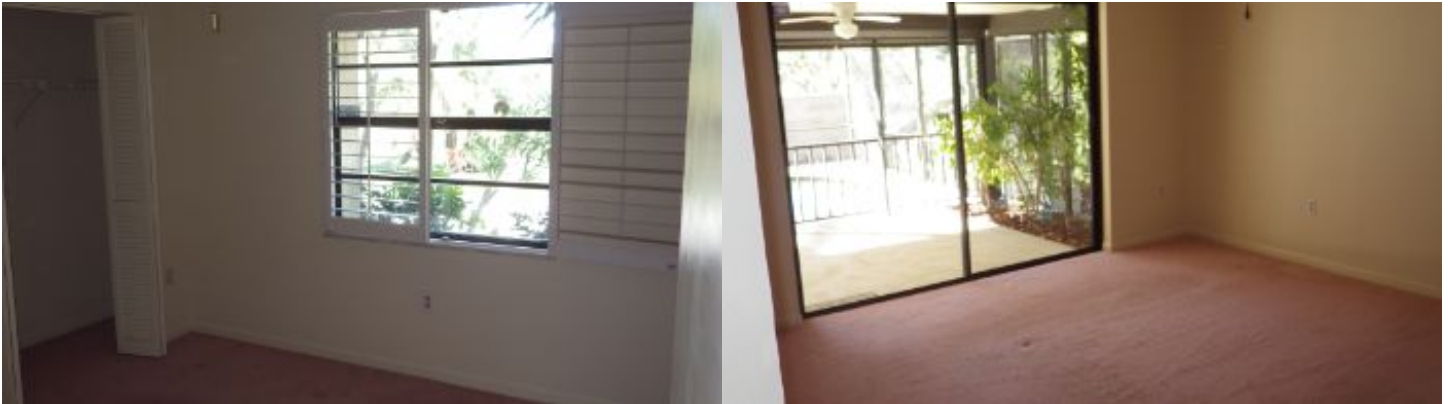
- Carpets and floors are generally in good condition with no major damage or staining noted.
- We always recommend replacing all smoke detectors when occupying a new home. Not just the batteries go bad with smoke detectors. Current studies indicate a useful life of 5 - 7 years and age is difficult to determine.
- Minor damage such as hanger holes, nicks and gouges observed in several areas. Repair and paint as necessary.
